The trouble-free operation of alternators is unavoidable to meet the rising demand for electrical energy. Any alternator failure causes overloading of the remainder of the units in a grid, posing a serious threat to network stability. In a stand-alone generation, production is seriously affected. The repairs of large capacity alternators require a trained workforce, which is not always locally available. When an alternator operates under typical fault conditions, it reduces its efficiency and shortens its lifespan. The synchronous generator's prolonged outage has an adverse impact on network reliability and impacts the economy. As a result, early detection of alternator anomalies significantly reduces fault extension, loss of supply, and maintenance costs, while also improving the alternator's life. In many cases, the early fault detection scheme for higher capacity alternators cannot be readily applied to a lower capacity one. The article discusses some practical root cause analyses of the commonly occurring faults in turbo-alternators. The identification, characteristics, and analysis of multiple fault occurrences have been thoroughly addressed. This article would provide utility

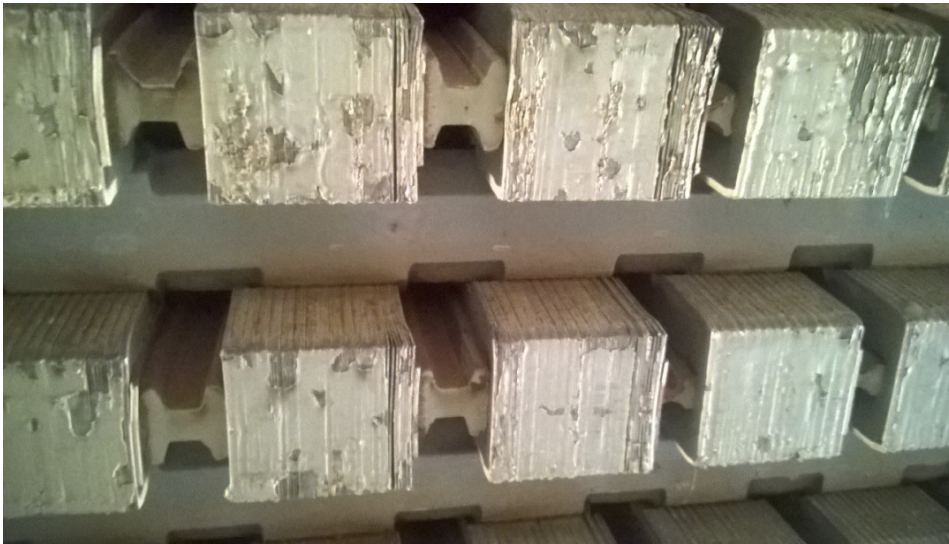
In 150 MW alternators, the diameter of the stator bore is of the order of a few meters and is made using segmented stampings. All the insulated Silicon hot-rolled stampings form the stator stack. Several packets of stampings are assembled in such a way as to create radial ducts for cooling purposes. As per existing conventions in tropical countries, after a packet of 10 cm, a gap of 1 cm is provided while stacking. It reduces the effective iron length and increases the coil line parameters, which calls for a larger copper volume for windings. A typical packet of stampings with radial ducts, partially burnt teeth, and loosened stampings are shown in Fig. 2. A single tooth along the axial length on the stator surface is discontinuous and segmented because of the stacking of stampings in packets with spacers inserted. Each packet of a tooth has proper insulation and bindings, which protects it against vibration. These are subjected to the magnetostriction phenomenon in which each stamping in a packet of tooth dances macroscopically in a haphazard manner when subjected to alternating magnetization [19]. It causes the loosening of specific tooth stampings. Due to prolonged use, a particular tooth packet may be subjected to several stresses mentioned earlier. Loosening of stampings ensues due to wear and tear, as shown in Fig. 2, in which slot insulation degradation can be initiated. When the insulation between the stampings degrades, there are chances of more significant eddy current losses in those packets of the tooth. Due to magnetostriction, the stampings devoid of insulation regularly appear in contact with each other in cyclic magnetization resulting in a rise in local eddy-current losses and a rise in local hot spot temperature.

Fig. 2. Start of Loosening of Core stampings in 150 MW alternator.

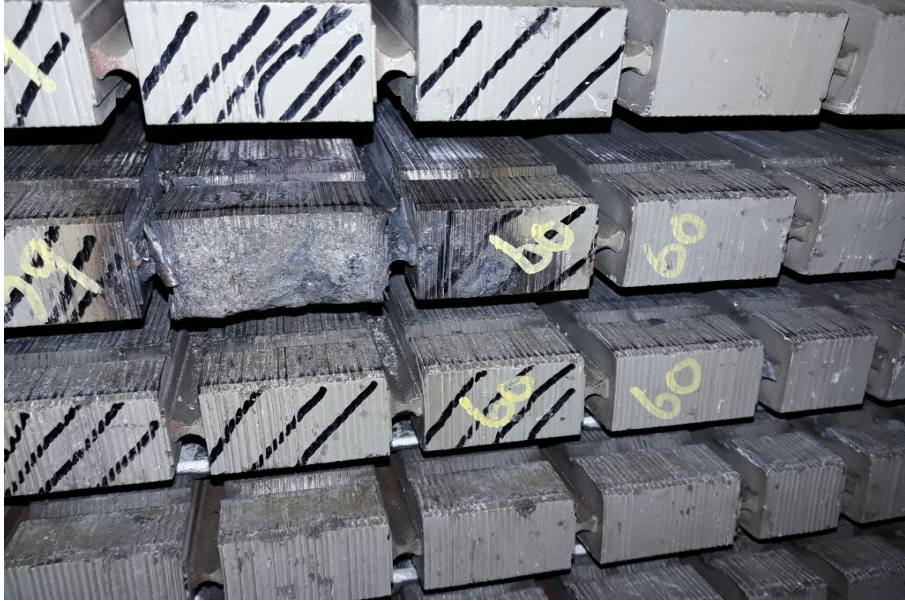
The Core burning is shown in Fig. 3. The core burning appears slowly and worsens gradually. The outlet air temperature recording cannot detect the tooth insulation burning and subsequent wear and tear and loosening of packets of stampings. It results in creating a local hotspot in the heart of the core. The melting temperature of electrical grade sheet steel

is around 1500 degrees Celsius, whereas the melting point of winding copper is about 1100 degrees Celsius. Due to the melting of the copper coil, insulation, and core material, just after the intense heating due to a fault, a lump of hot material protrudes, touching several teeth on the rotor, shaft, etc.

Fig. 3. Burning of packets of tooth stampings in the core.

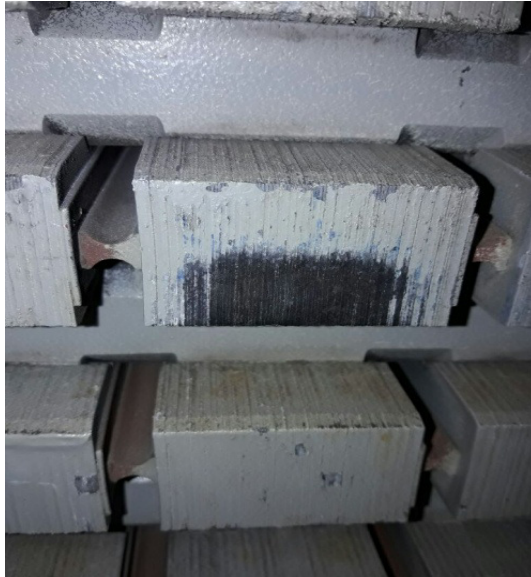
Upon coming in contact with the teeth, the hot lump leaves a scar which eventually short circuits the stampings on the face, as shown in Fig. 4. However, when such stamping packets are used again, it leads to core burning unless properly treated with care. It calls for an online chemical analysis of outlet air, which can detect the possible faults of core burning at an early stage. However, these schemes are not available for 150 MW alternators. Core burning causes the local degradation of Class F insulation above 155° C (coil insulation) and the subsequent grounding of the coil with the core. The core burning (of a tooth) in a 150 MW alternator makes a portion of the stator core unusable. In a refurbished alternator's core, such portions of the core are removed, resulting in lowering the alternator's capacity.

Fig. 4. Molten lump of stator winding coming in contact with slot-tooth, leaving a mark.

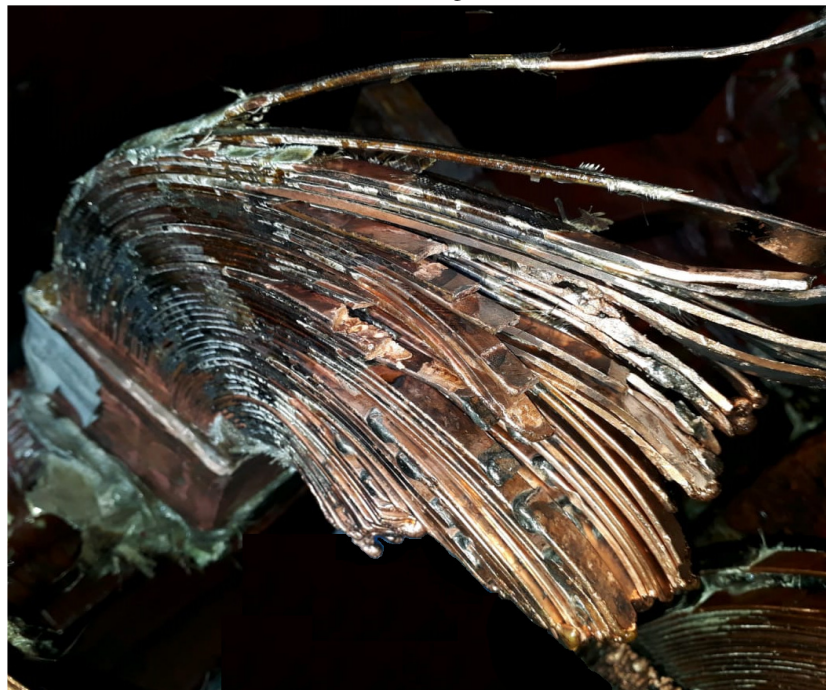
A damaged coil showing a strip conductor is shown in Fig. 6. Due to manufacturing defects of possibly undetectable void in copper strips or possible bend or presence of foreign material during manufacturing, the creation of a hot spot surrounding the void/bend remains undetectable. The copper strip manufacturer and high voltage coil winding company should ensure void-free strips after rigorous testing of copper winding strips and the binding process. Over longer run under overloading conditions may cause a break in such defective conducting strips. The current interruption in a broken strip result in a higher current density in healthy conducting strips. It also results in partial discharge (PD) between an embedded conductor's minute gap and between the conductor and the slot. Both the ends of a broken coil are at higher potential. This sudden discharge may eventually melt the healthy strips, thermal failure of coil insulation, which results in the coil getting earthed through the grounded core, resulting in the L-G fault. A break in the continuity of any strip due to unforeseen reasons will cause the coil's parameters to change, resulting in a slight dip in the voltage and vibration-related issues due to magnetic unbalance. The winding faults often remain undetectable when a fault is close to the neutral ground.

Fig. 6. A damaged coil showing burnt strip conductors in a typical high voltage alternator (Courtesy: Proclaim).

The rating of an alternator is 187.5 MVA, 150 MW, 15.75 kV, 3000RPM. Each phase had two parallel paths, and one of the R phase windings was found to be earthed 45% from neutral when it was providing 145.50 MW to the grid at 15.78 kV, 5,642.71 A, 49.62 Hz.

Due to unforeseen reasons, such pre matured faults cannot be detected in advance unless real-time chemical fume detection of outlet air technique is available for lower capacity alternators. According to IEEE SG protection rules [20], thermal protection for the SG stator core and windings may be given for (a) Generator overloading, (b) Leading Power factor operation, (c) Faulty cooling system, and (d) Localized hot spots caused by core lamination insulation failure or by localized or rapidly developing winding failures. In the present case, both the core burning and LG fault were present. There is no scheme to detect hot spot creation in 150MW alternators. It is also difficult to pinpoint which fault supported the other fault.

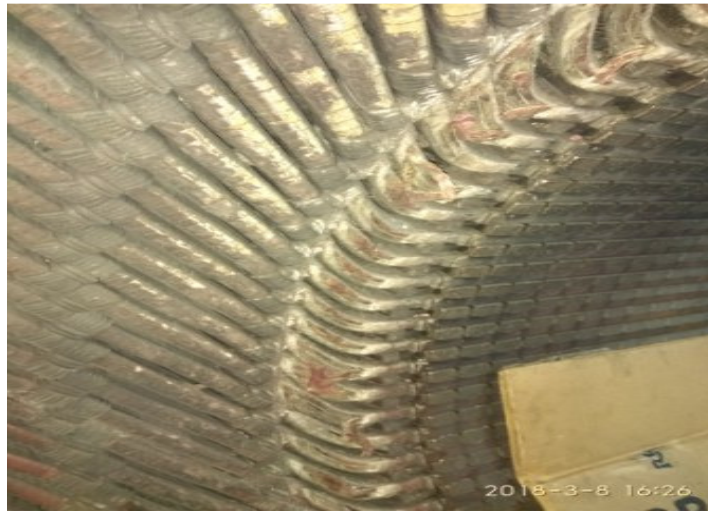
their slots was accompanied by significant gravitational and electromagnetic pressures (electrodynamical-force and thermo-mechanical stresses) in the radial downward direction. The significantly displaced windings can occasionally damage the restraining slot wedge and reinforcing bands. Under dynamic situations, this may produce a severe dislocation of the stator winding coils in the upper half in horizontal shaft machines, which may come in contact with the rotating structure in overhang regions. A typical deformation due to dislocation of the stator winding of a 15 MW, 11kV, 50 Hz, 1500 RPM, 4-pole Steam Turbo stand-alone generator supplying arc furnace has been shown in Fig. 7. A portion of the stator winding came in direct contact with the rotor overhang, thereby puncturing glass insulation on the overhang portion of the rotor, as shown in Fig. 8.

Fig. 7. Deformation of 15 MW, alternator due to dislocation.

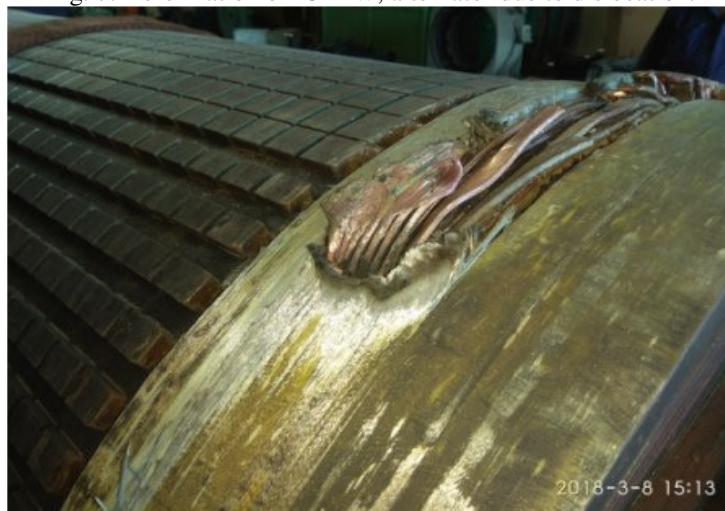
Fig. 8. Puncturing of glass insulation covering the overhang portion of the rotor due to dislocation of stator winding causing direct contact with the rotor.

It shows the dislocation of the windings and insulation rupture in the overhang region of the rotor. It may be due to excessive vibration, non-operation of the field failure relay, leading to the induction generator operation, or ruling power factor operation, ultimately breaking the restraining band that holds the overhang portion firmly. Such a type of fault is difficult to predict unless visual inspections of the alternator's rotating and stationary coil structures are recorded online, and corrective measures are taken in advance. Such instrumentation requires inexpensive digital cameras and online recording of crucial moving and static structures.

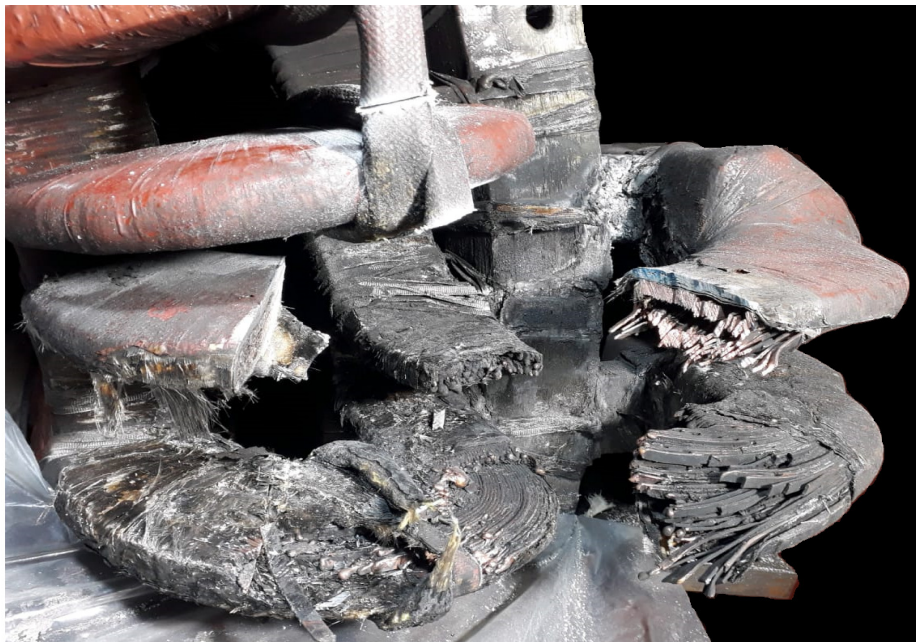
Nose joints connect the end terminals of phase windings to the bus bars connecting it to the panel. The end windings typically consist of several strip conductors which are insulated from each other, but at the end, these are short-circuited and fused with the connecting conductor to the bus bars. It is achieved by applying certain chemical compounds, which help forge the end winding terminals with the bus bars uniformly. Any flaw during the manufacturing process, formation of an air pocket or void inside the copper material increases the current density in the vicinity of the void/air pocket, causing hot spots. Over long runs, the metallurgical composition inside the copper material gets altered. Along with this and other environmental stresses such as vibrations, electrical heating due to overloading may dislodge the bus bar connecting the cable terminals with multiple ends winding conductors, causing insulation damage and disconnection of that phase.

Fig. 9. Nose Joint Failure.

In an alternator with multiple parallel paths, the requirement of connecting multiple thick conductors, each having several strip conductors, to a common conductor is a more stringent manufacturing process. Fig. 9 shows a typical dislodging of the nose joint in a high voltage alternator.
