The trouble-free operation of alternators is unavoidable to meet the rising demand for electrical energy. Any alternator failure causes overloading of the remainder of the units in a grid, posing a serious threat to network stability. In a stand-alone generation, production is seriously affected. The repairs of large capacity alternators require a trained workforce, which is not always locally available. When an alternator operates under typical fault conditions, it reduces its efficiency and shortens its lifespan. The synchronous generator's prolonged outage has an adverse impact on network reliability and impacts the economy. As a result, early detection of alternator anomalies significantly reduces fault extension, loss of supply, and maintenance costs, while also improving the alternator's life. In many cases, the early fault detection scheme for higher capacity alternators cannot be readily applied to a lower capacity one. The article discusses some practical root cause analyses of the commonly occurring faults in turbo-alternators. The identification, characteristics, and analysis of multiple fault occurrences have been thoroughly addressed. This article would provide utility

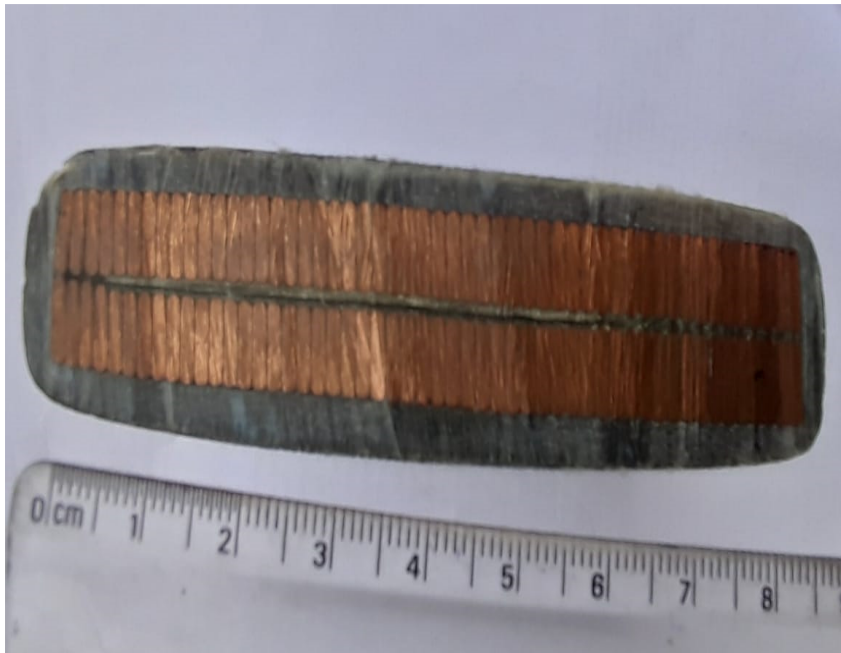
A typical cross-section of the coil of an 11 kV, 50 Hz, 150 MW, the grid-connected air-cooled alternator is shown in Fig. 5. It has two conductors per slot in single-layer windings. The preformed casted coil has several strips wrapped using Kapton tape insulation, and Class F insulation binds the coil. These strips are short-circuited on both the ends of windings to allow a large current to flow. Two conductor groups are separated by insulation.

Fig. 5. Cross Section of the coil of a typical High Voltage 150 MW alternator winding.
